Avey's Run Stream Restoration Project

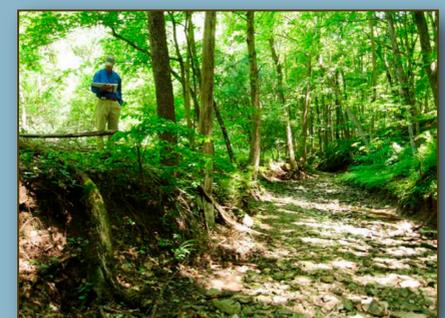
Steep edges of the channelized stream before restoration

Over 150 years ago, a healthy stream (a tributary of Avey's Run that flows into the East Fork Little Miami River) meandered through what is now Cincinnati Nature Center. Around 1850, a farmer "channelized" the stream, straightening it to provide more space for fields. Flooding from rain water gouged the channel, making it deeper and wider, and carrying off soil and nutrients. Over time the channel, with its rushing flood waters, became unsafe for aquatic organisms.

Increased development on nearby lands created more rain water runoff from impermeable surfaces like roads, parking lots and roofs. Development also decreased the permeable land available to absorb this runoff, causing more water to pour into the channel. More and more soil continued to wash away and the silt was deposited downstream. All of this resulted in the stream pictured above and led to a degraded habitat both in the channel and downstream.

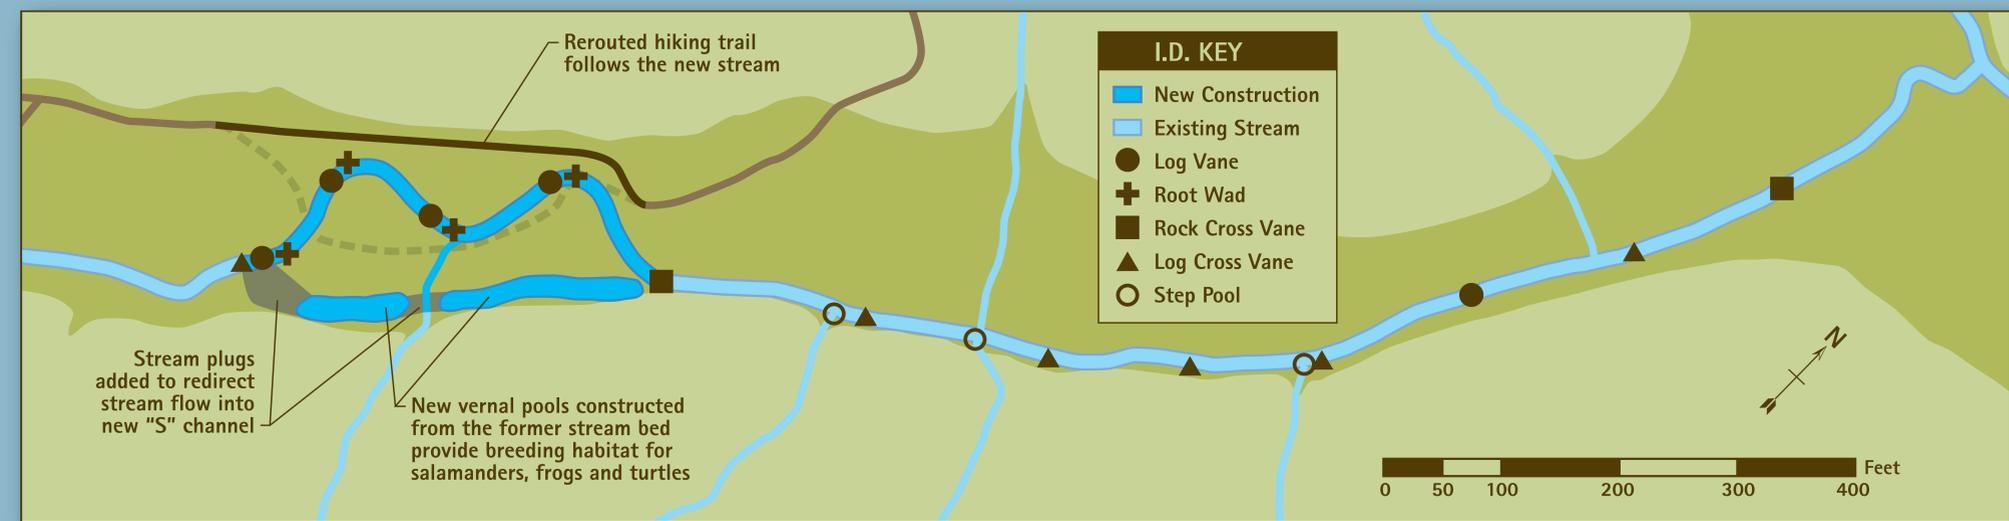
Rock and Log Vanes
Rock and log vanes create deep pools of water, helping stabilize the streambed and allowing a variety of aquatic animals to inhabit the stream.

Stream Edges
Stream banks were stabilized with burlap and other biodegradable mesh, grass seed and native plantings. Root wads (tangles of tree roots) were purposefully placed along the bank for stabilization and to provide excellent fish habitat.

Riffles
Local limestone rocks were used to create riffles (shallow, rocky areas) to help the stream properly deposit sediment and to provide important habitat for small aquatic invertebrates.

The first step in restoration was to dig a shallow, narrow, S-shaped stream. This replaced the straight, deep channel and allowed it to be filled in. The new stream was designed to allow flood waters to slow down, overflow the banks, and penetrate into the floodplain. Stabilizing structures were installed in and around the new stream to keep it from eroding and to create habitat for aquatic organisms.

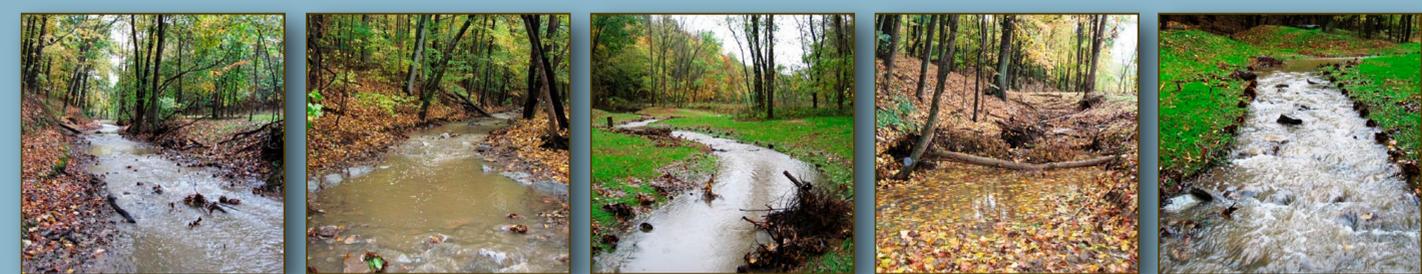
Photos of the stream taken after a heavy rainfall

Today, the stream is healthy and has increased biodiversity. The streambed is stable and can handle large quantities of water from heavy rains. The water quality both in and downstream will continue to improve over time.
